NATIONAL TRANSPORTATION SAFETY BOARD

RAILROAD ACCIDENT REPORT

ILLINOIS CENTRAL GULF
RAILROAD COMPANY
FREIGHT TRAIN DERAILMENT
HAZARDOUS MATERIAL RELEASE
AND EVACUATION
MULDRAUGH, KENTUCKY
JULY 26, 1980

NTSB-RAR-81-1

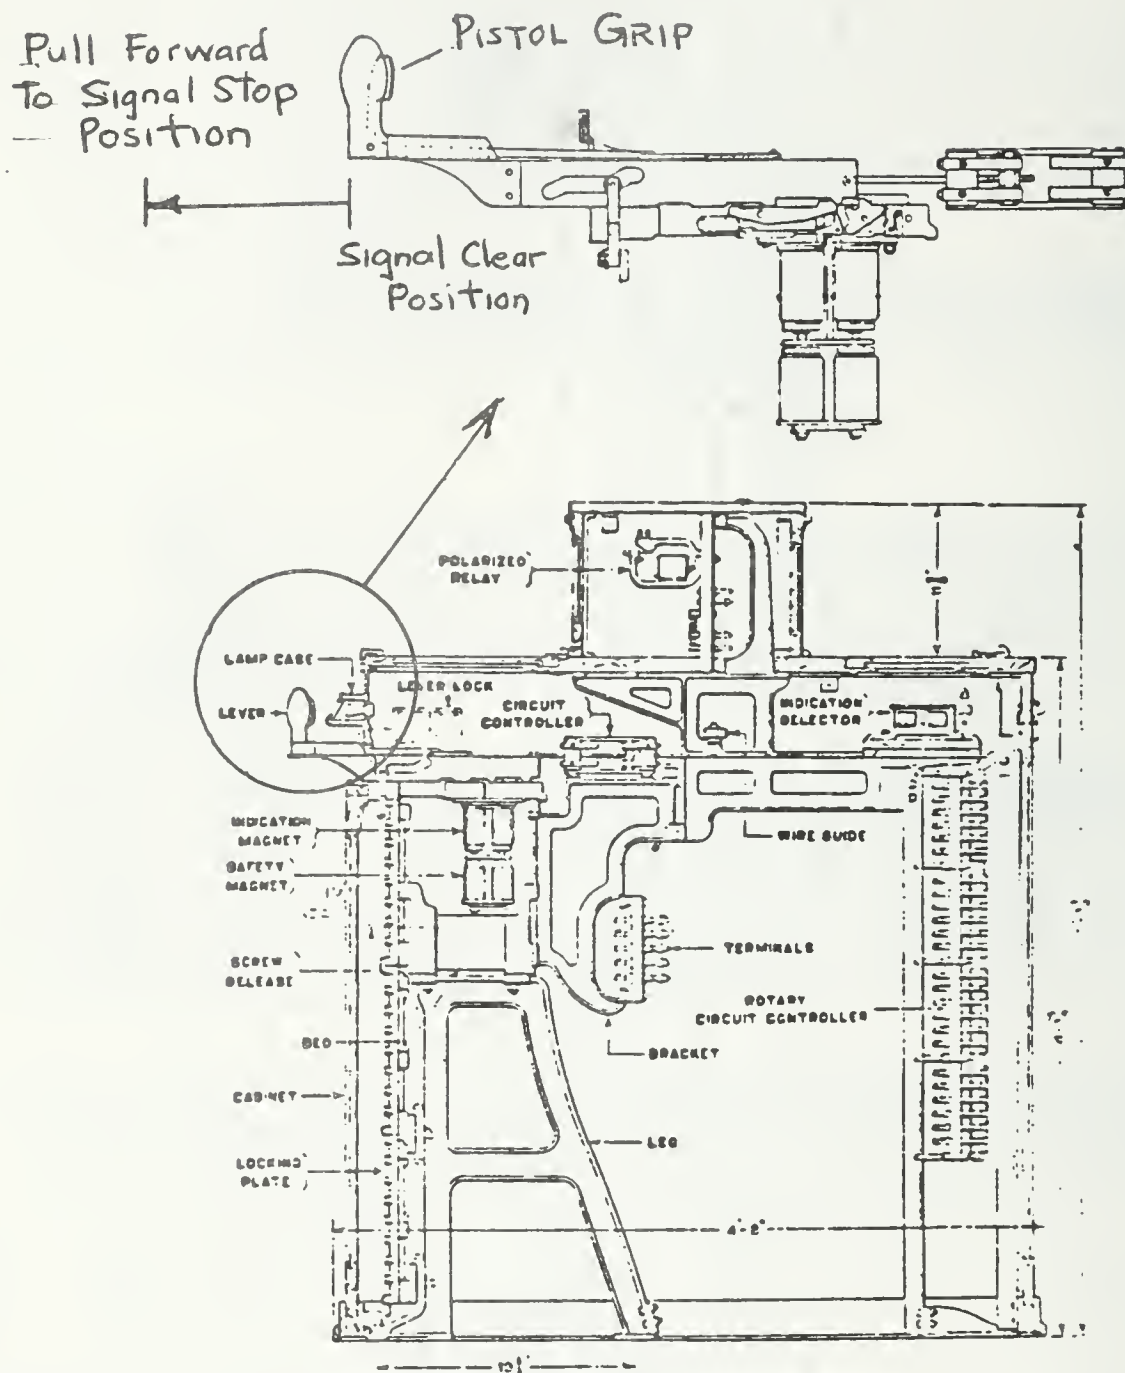
Figure 6.-- Unit lever-type machine.

The OW interlocking tower has a unit lever-type machine. (See figure 6.) The machine is equipped with 56 hand-operated levers: 33 levers control 34 signals; 19 levers control 20 switches, 3 levers control 4 electric locks, and there is 1 spare lever. The levers are a pistol grip-type which can only be moved by depressing the trigger in the handle. (See figure 6.) The blocking devices are metal boxes with opened ends.

1. The operator at OW interlocking operated the signal lever which permitted train No. 74 to obtain a clear signal because he failed to remember that an opposing train order was issued to OPSE-7 and that he had not applied a blocking device to the signal lever.

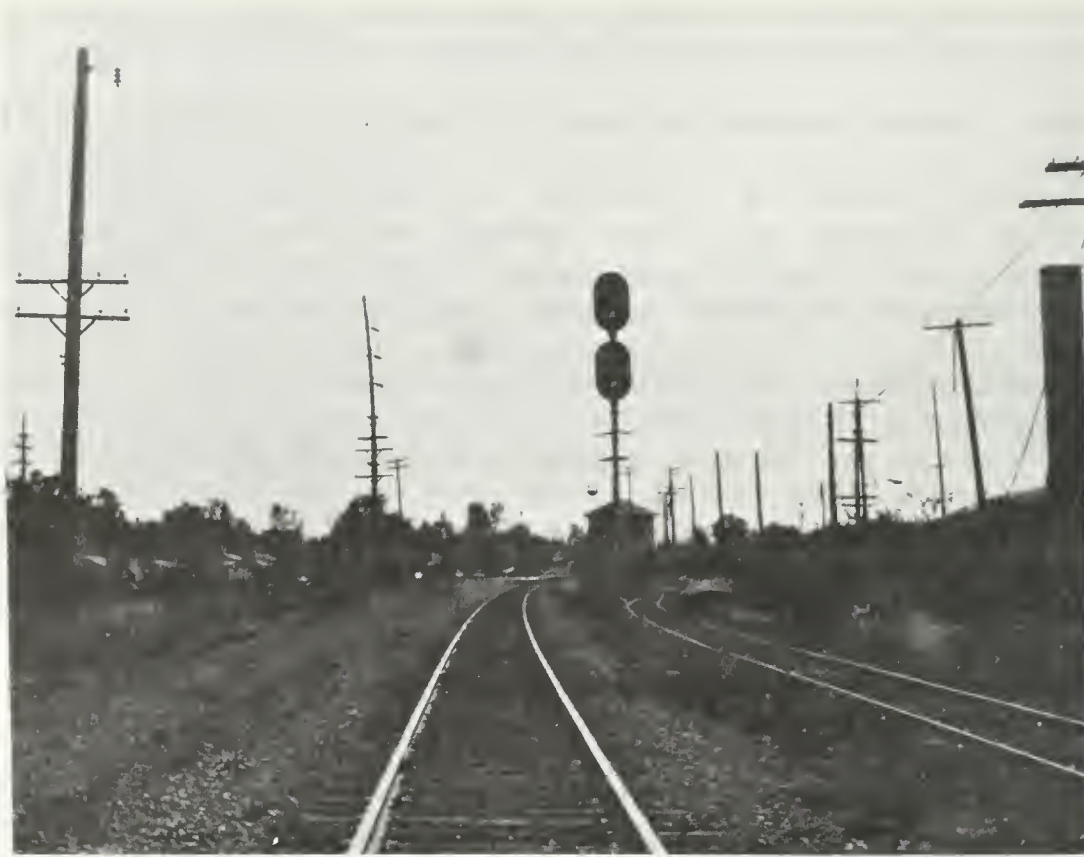
Coincident with the track changes, the southbound and northbound main tracks between the new junction and Iles South were redesignated tracks No. 1 and No. 2, respectively. The new junction was initially called Iles and the old Iles interlocking was renamed N&W Crossing interlocking. (See figure 1.) Early in 1976, ICG completed the new access line from former Illinois Central trackage adding a third No. 10 turnout at the

Figure 1.—View from southbound train approaching the home signal and tower at Iles. Iles Avenue crossing is beyond the tower.

new Iles interlocking. Later in 1976, the southbound home signal for the N&W crossing was changed to continuous-lighted color-light type with two signal heads on a mast to the west of the southbound main track. (See figure 1.) Finally, at the end of 1978, the northbound main track from N&W Crossing interlocking to Ridgely Yard was removed and the former southbound main track was placed under CTC.

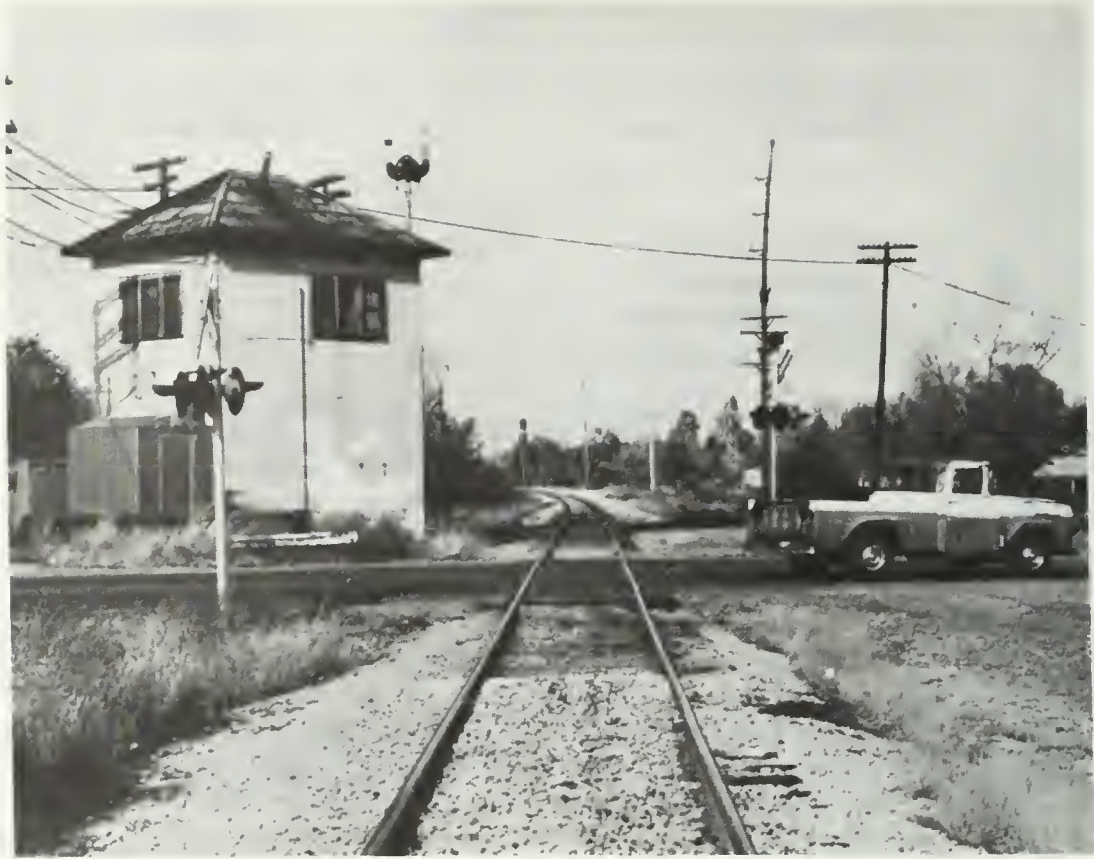
Figure 2.--Alton Division main track viewed facing north, showing southbound approach to N&W crossing and Iles Tower. Iles Avenue crossing is in the foreground.

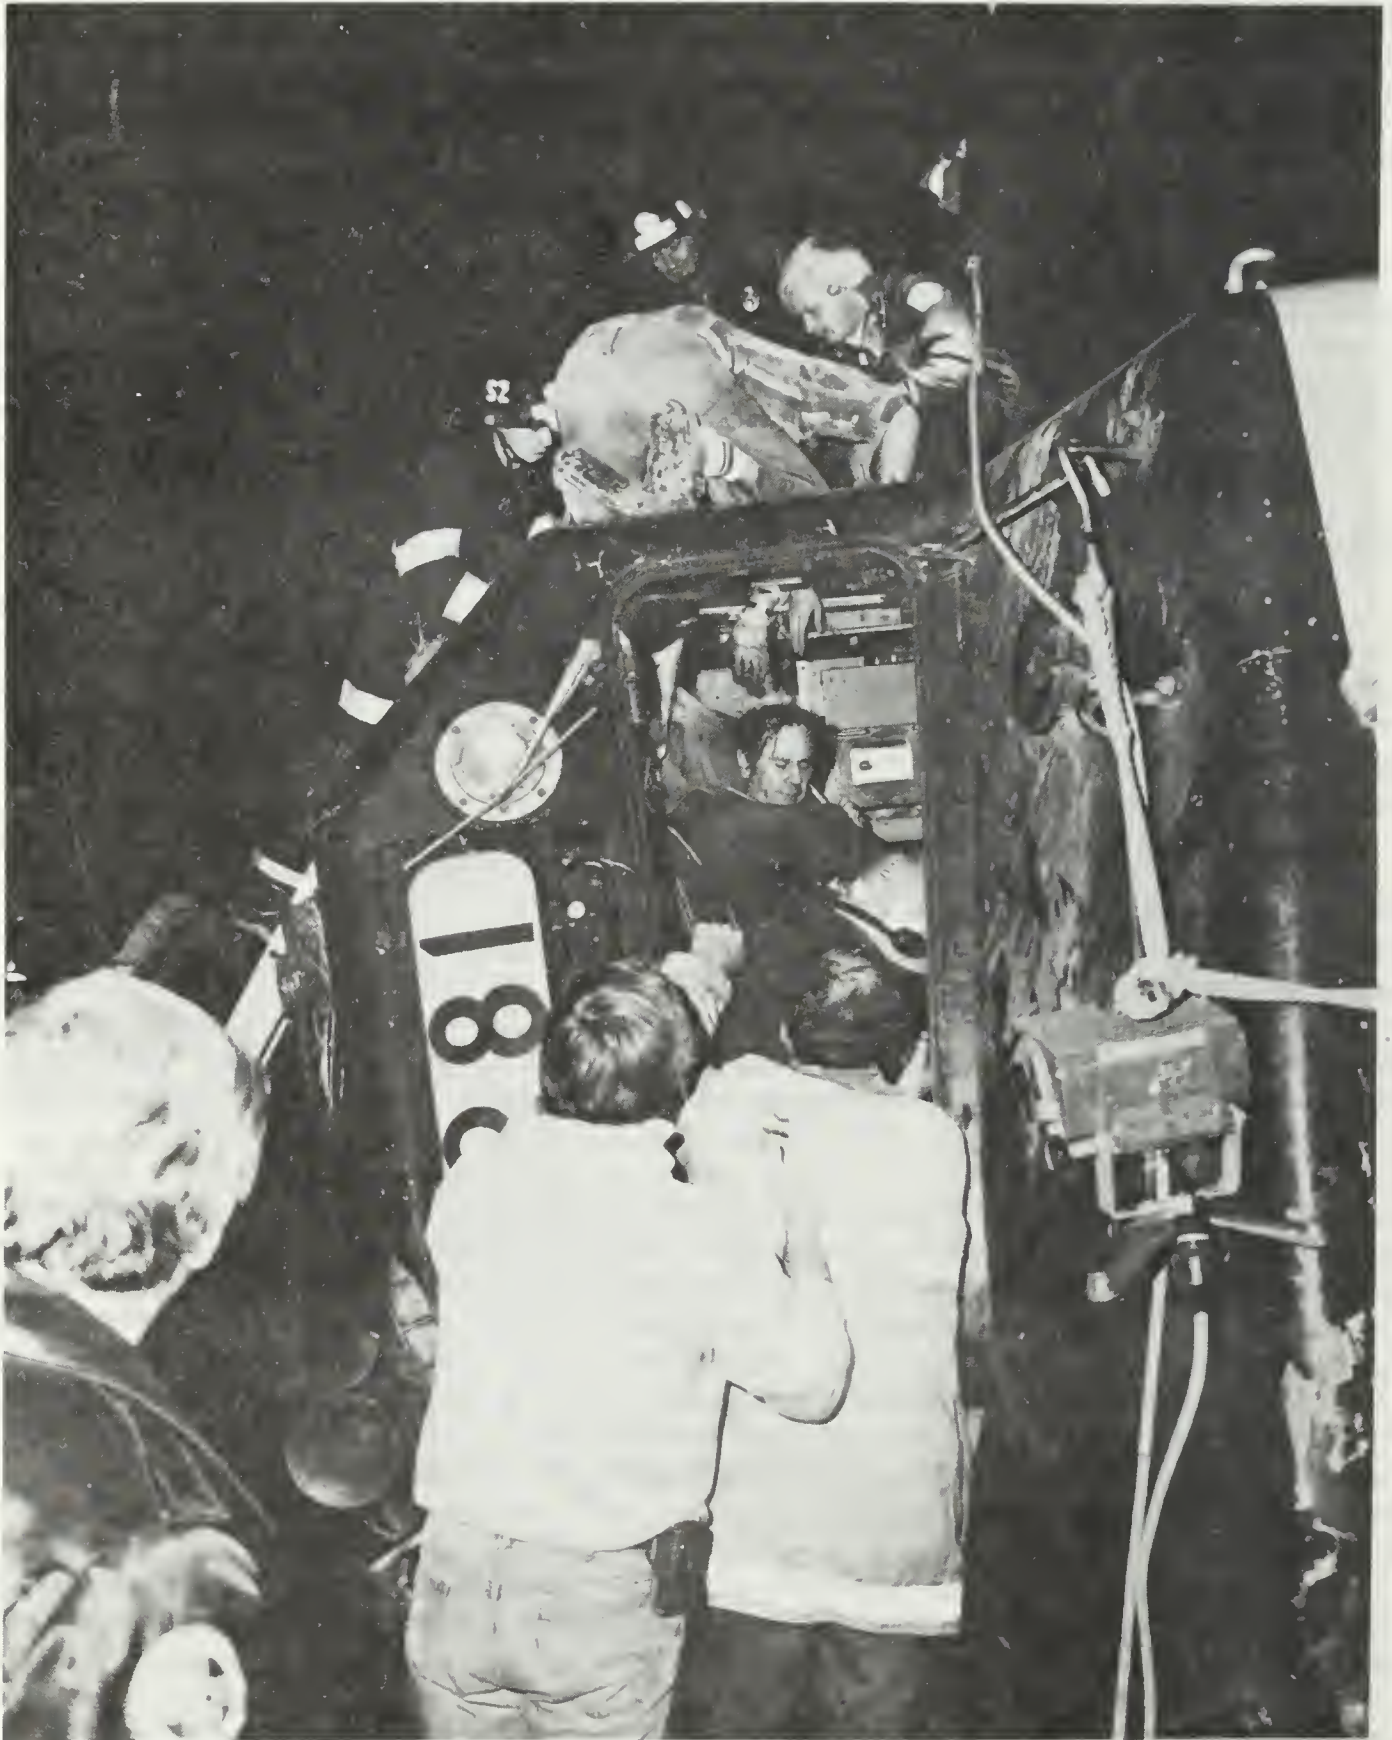
No meaningful postaccident observation of the locomotive controls could be made since it was necessary for rescuers to move the various control handles in the process of releasing the engineer from the operator compartment.

Figure 3.--Emergency personnel removing the engineer from the lead locomotive unit of Amtrak No. 21 about 90 minutes after the train derailed.

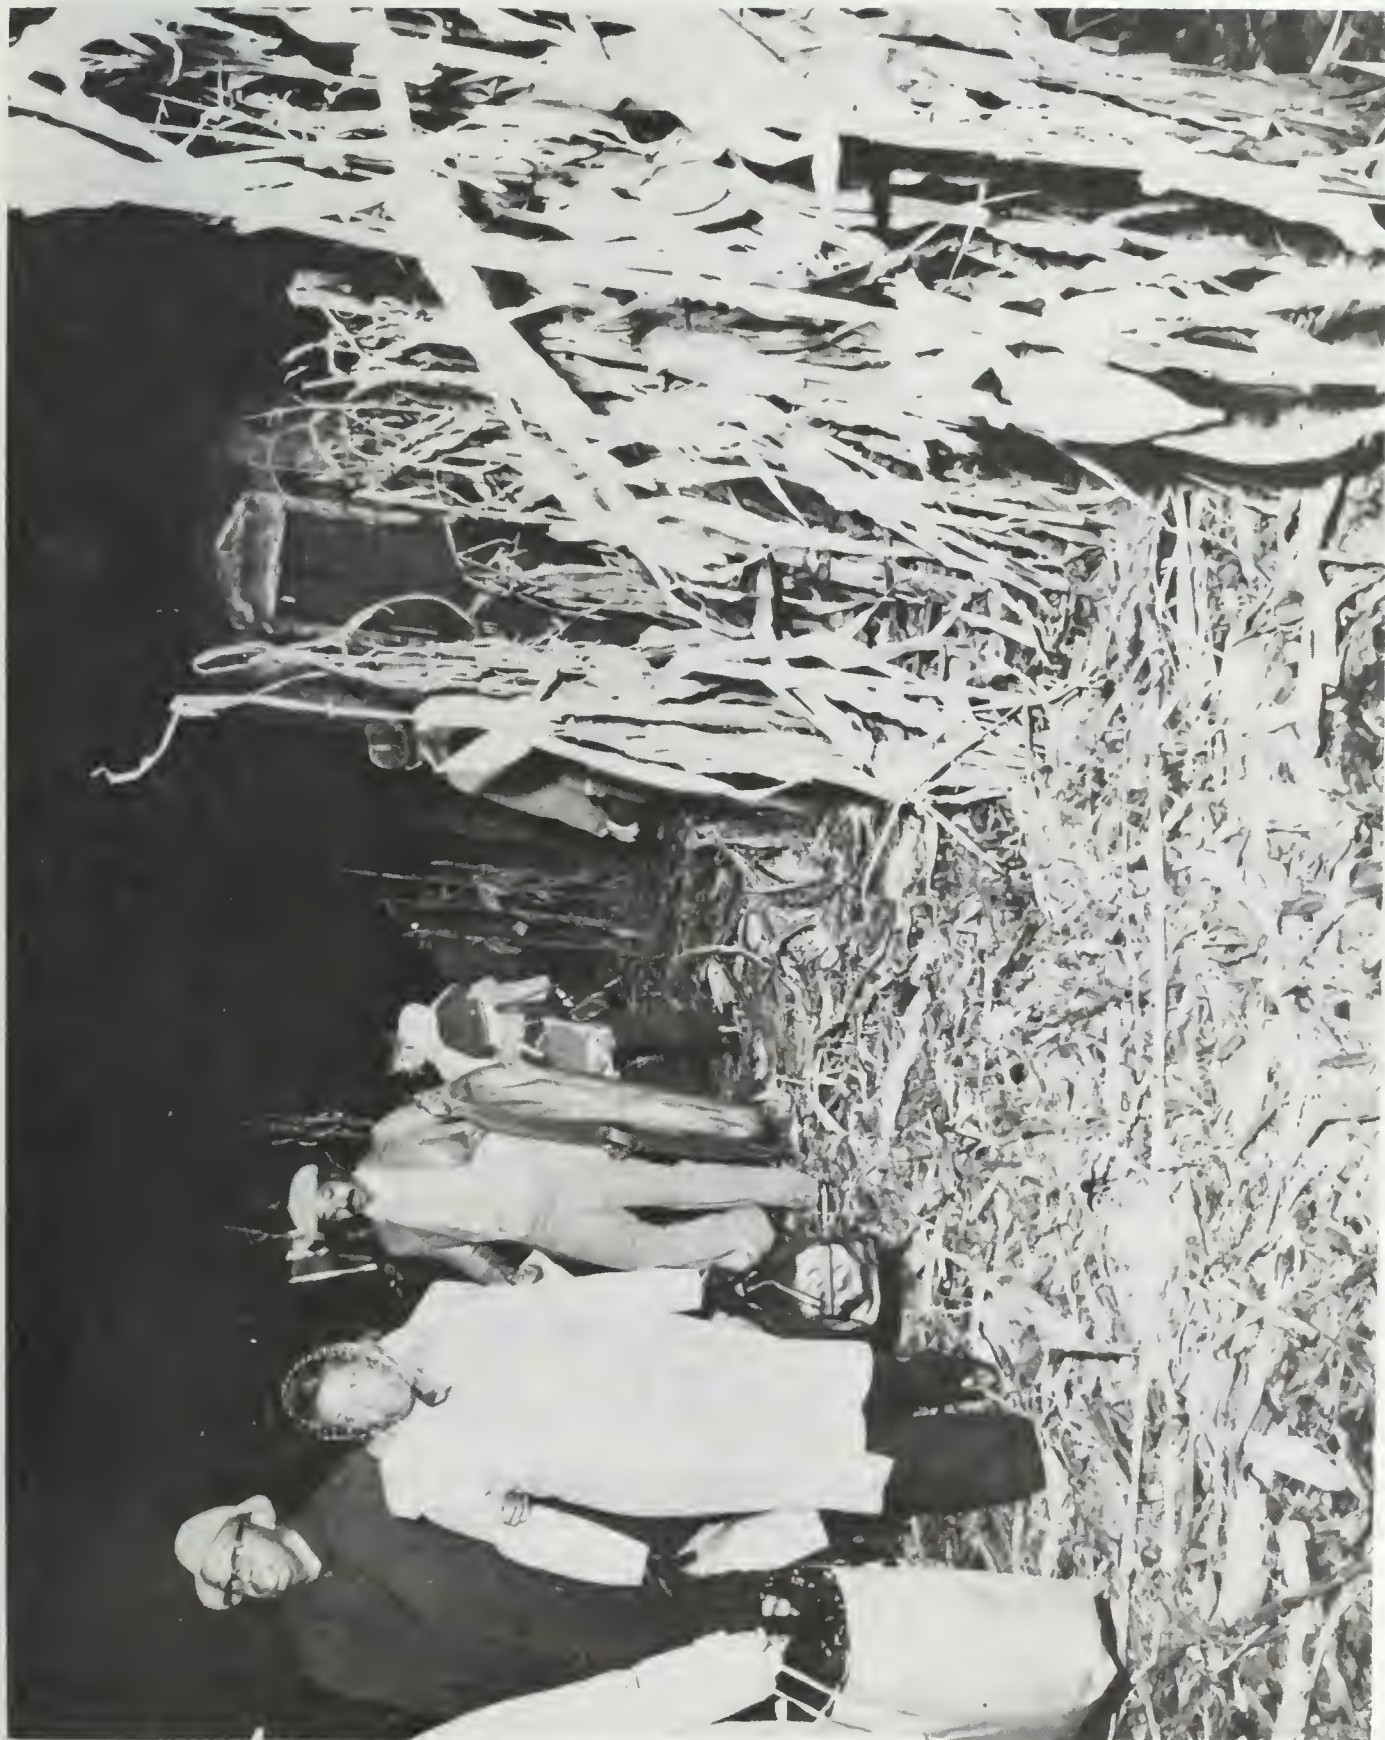
Figure 4.—Passengers of Amtrak No. 21 during the evacuation
from the derailment area.

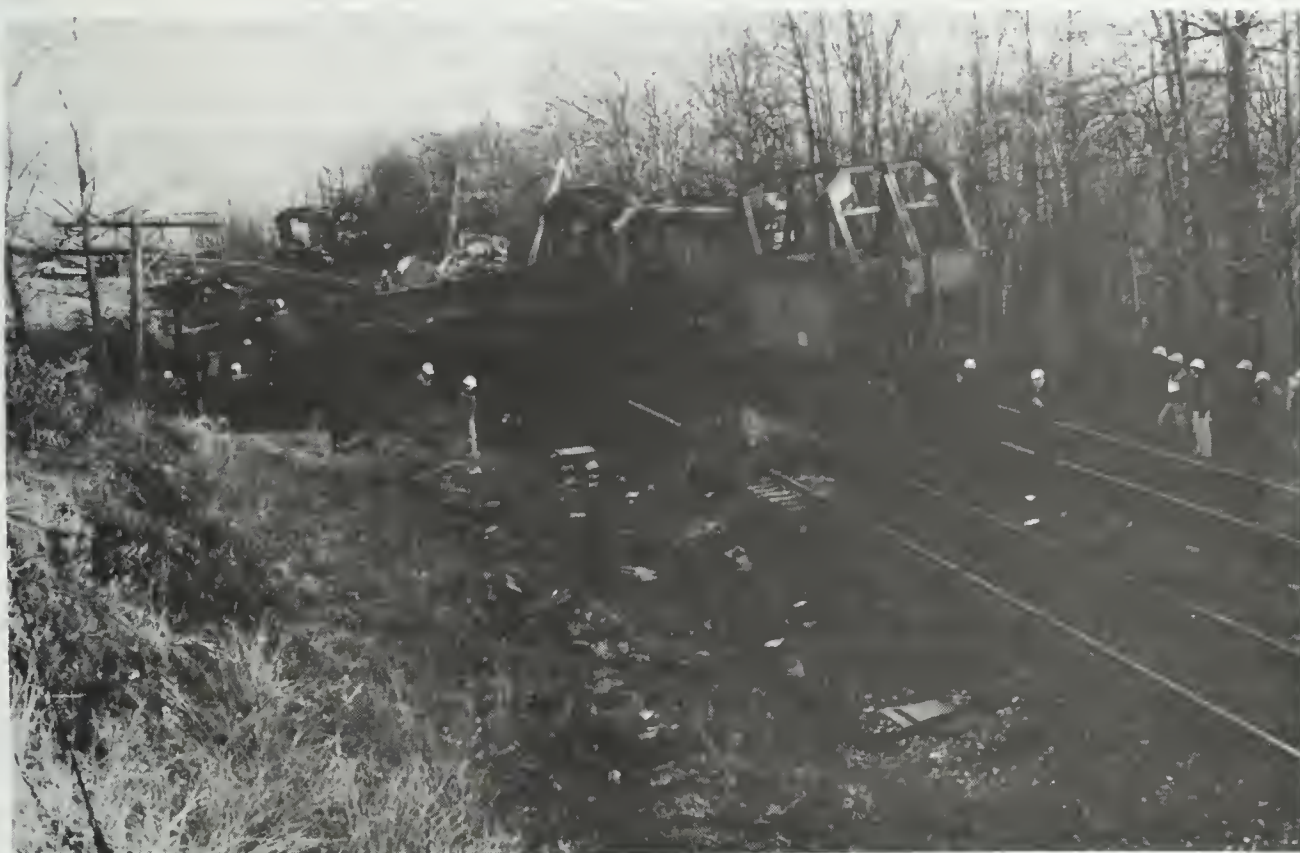
When the lead unit of No. 88 overturned, it landed on a low bank and fell on the engineer from the Brunswick Helper and pinned him so that he could not free himself. The brakeman of the Brunswick Helper and the engineer of No. 88 were not seriously injured, and they were able to free the engineer. (See figure 2.)

Figure 2.--Scene of accident.

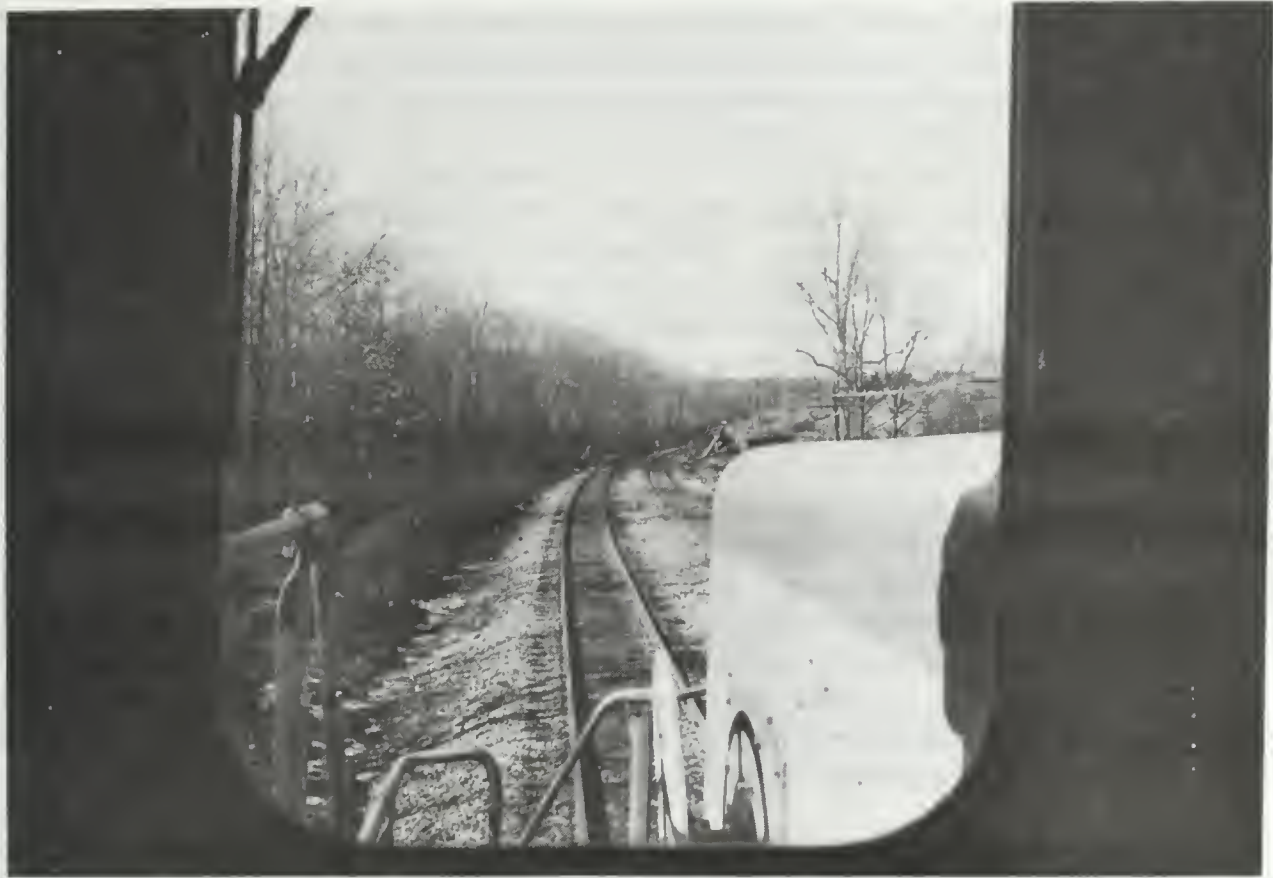
Figure 5.--View of train No. 88 from the Brunswick Helper (simulation).

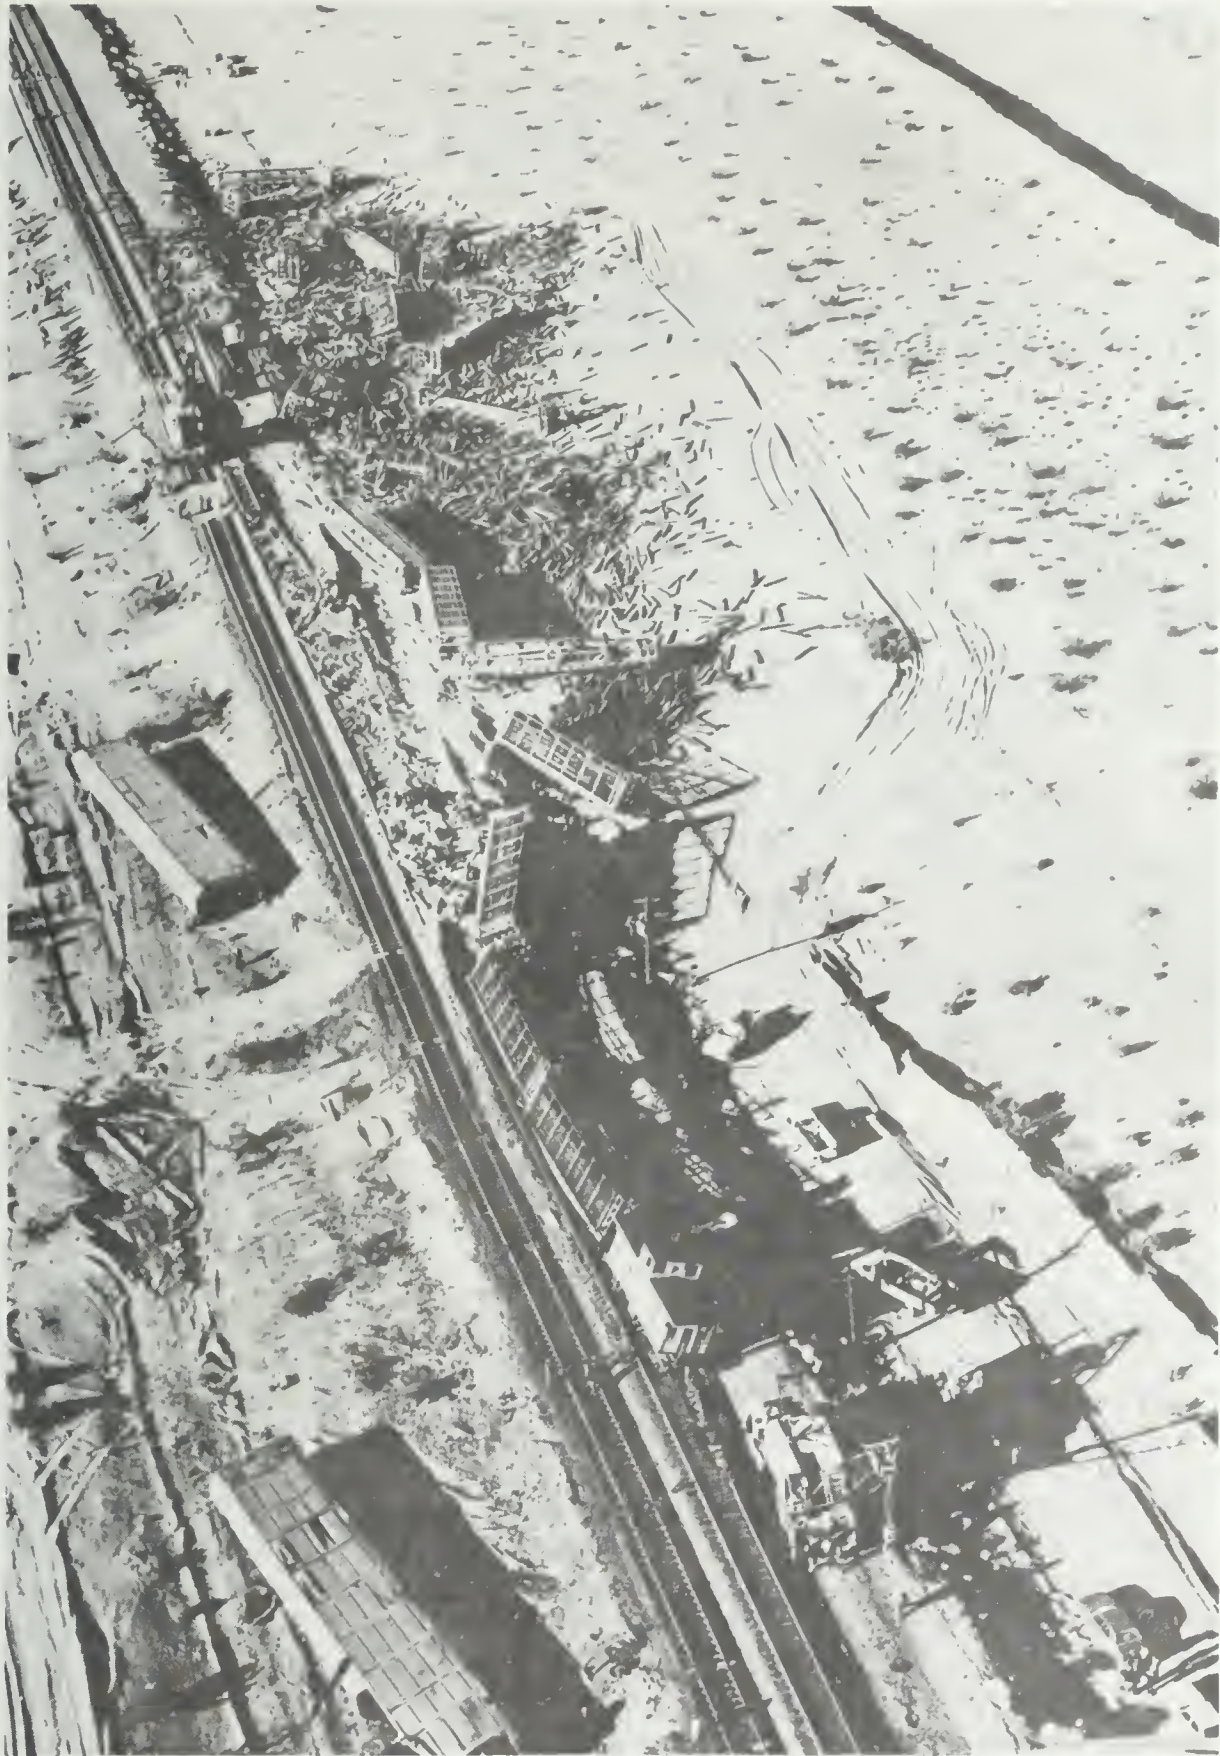
The general derailment area began about 500 feet west of the initial collision location and extended for 700 feet farther west. The locomotive unit of Extra 3119 West stayed on the track structure and came to a stop about 2,100 feet west of the original point of collision and 1,900 feet west of the caboose of Extra 3119 West.

Figure 2.--Aerial view of accident location viewed to the west. The caboose and cars of Extra 3119 West are to the right of the tracks. Derailed auto rack cars of the VAN train are to the left. The left-hand track was constructed after the accident for train operations during wreckage clearing operations.

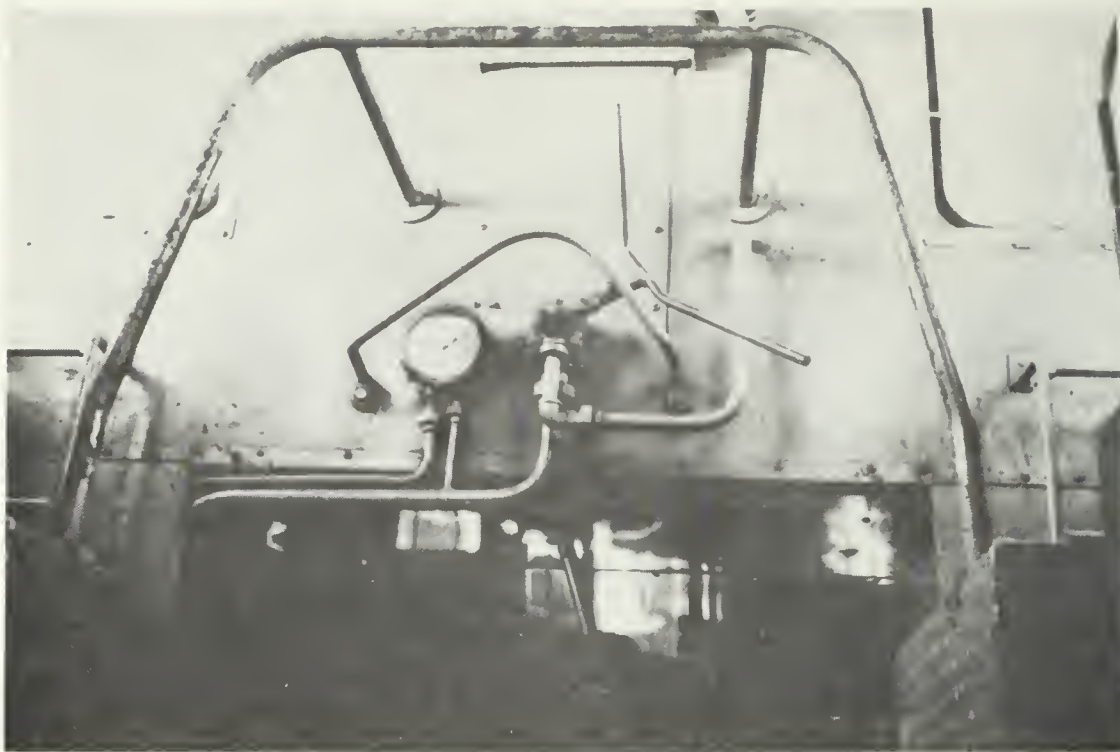
Figure 3.--Interior view of UP 25668, the caboose of Extra 3119 West, showing cupola bulkhead wall with type A-1 graduated caboose brake valve and dual-needle air pressure gauge. Viewed as found at the accident site facing forward or west.

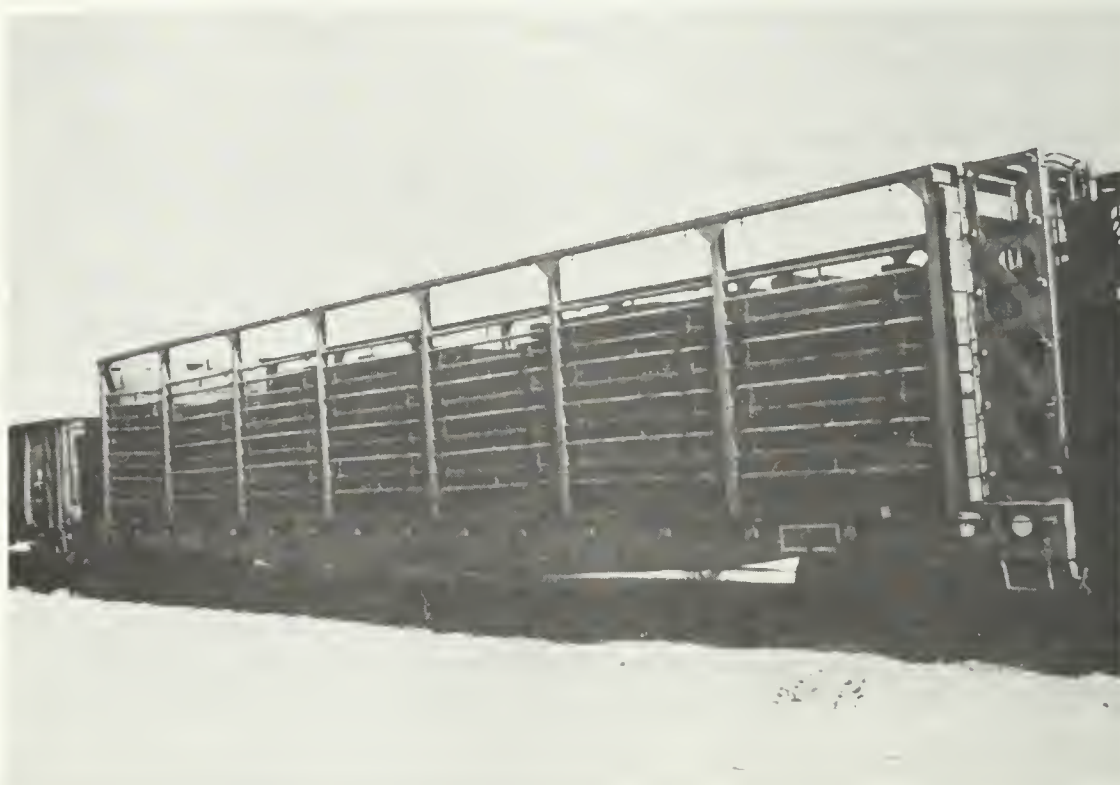
Figure 4.--Partly-loaded UP 913000-series bulkhead flatcar modified for hauling crossties. This car was of the same type and class as the tie cars in Extra 3119 West.

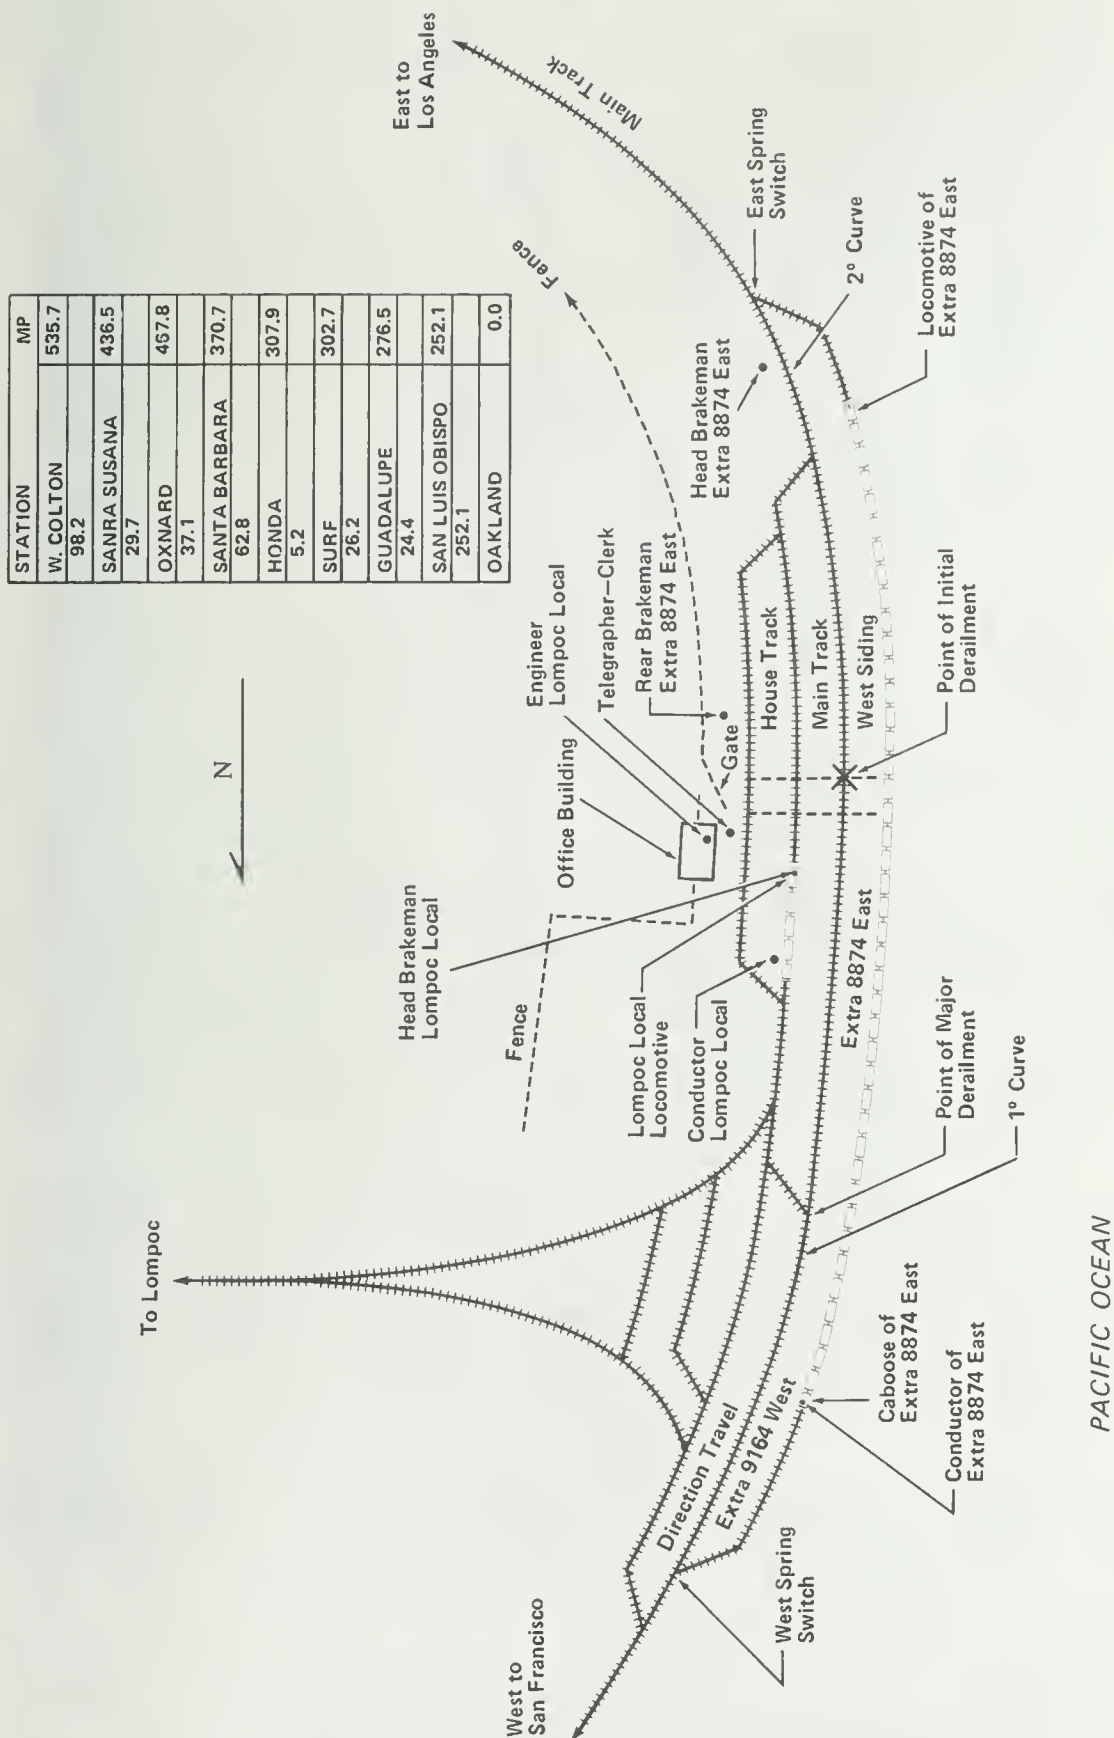
Figure 1.--Plan view of accident site.

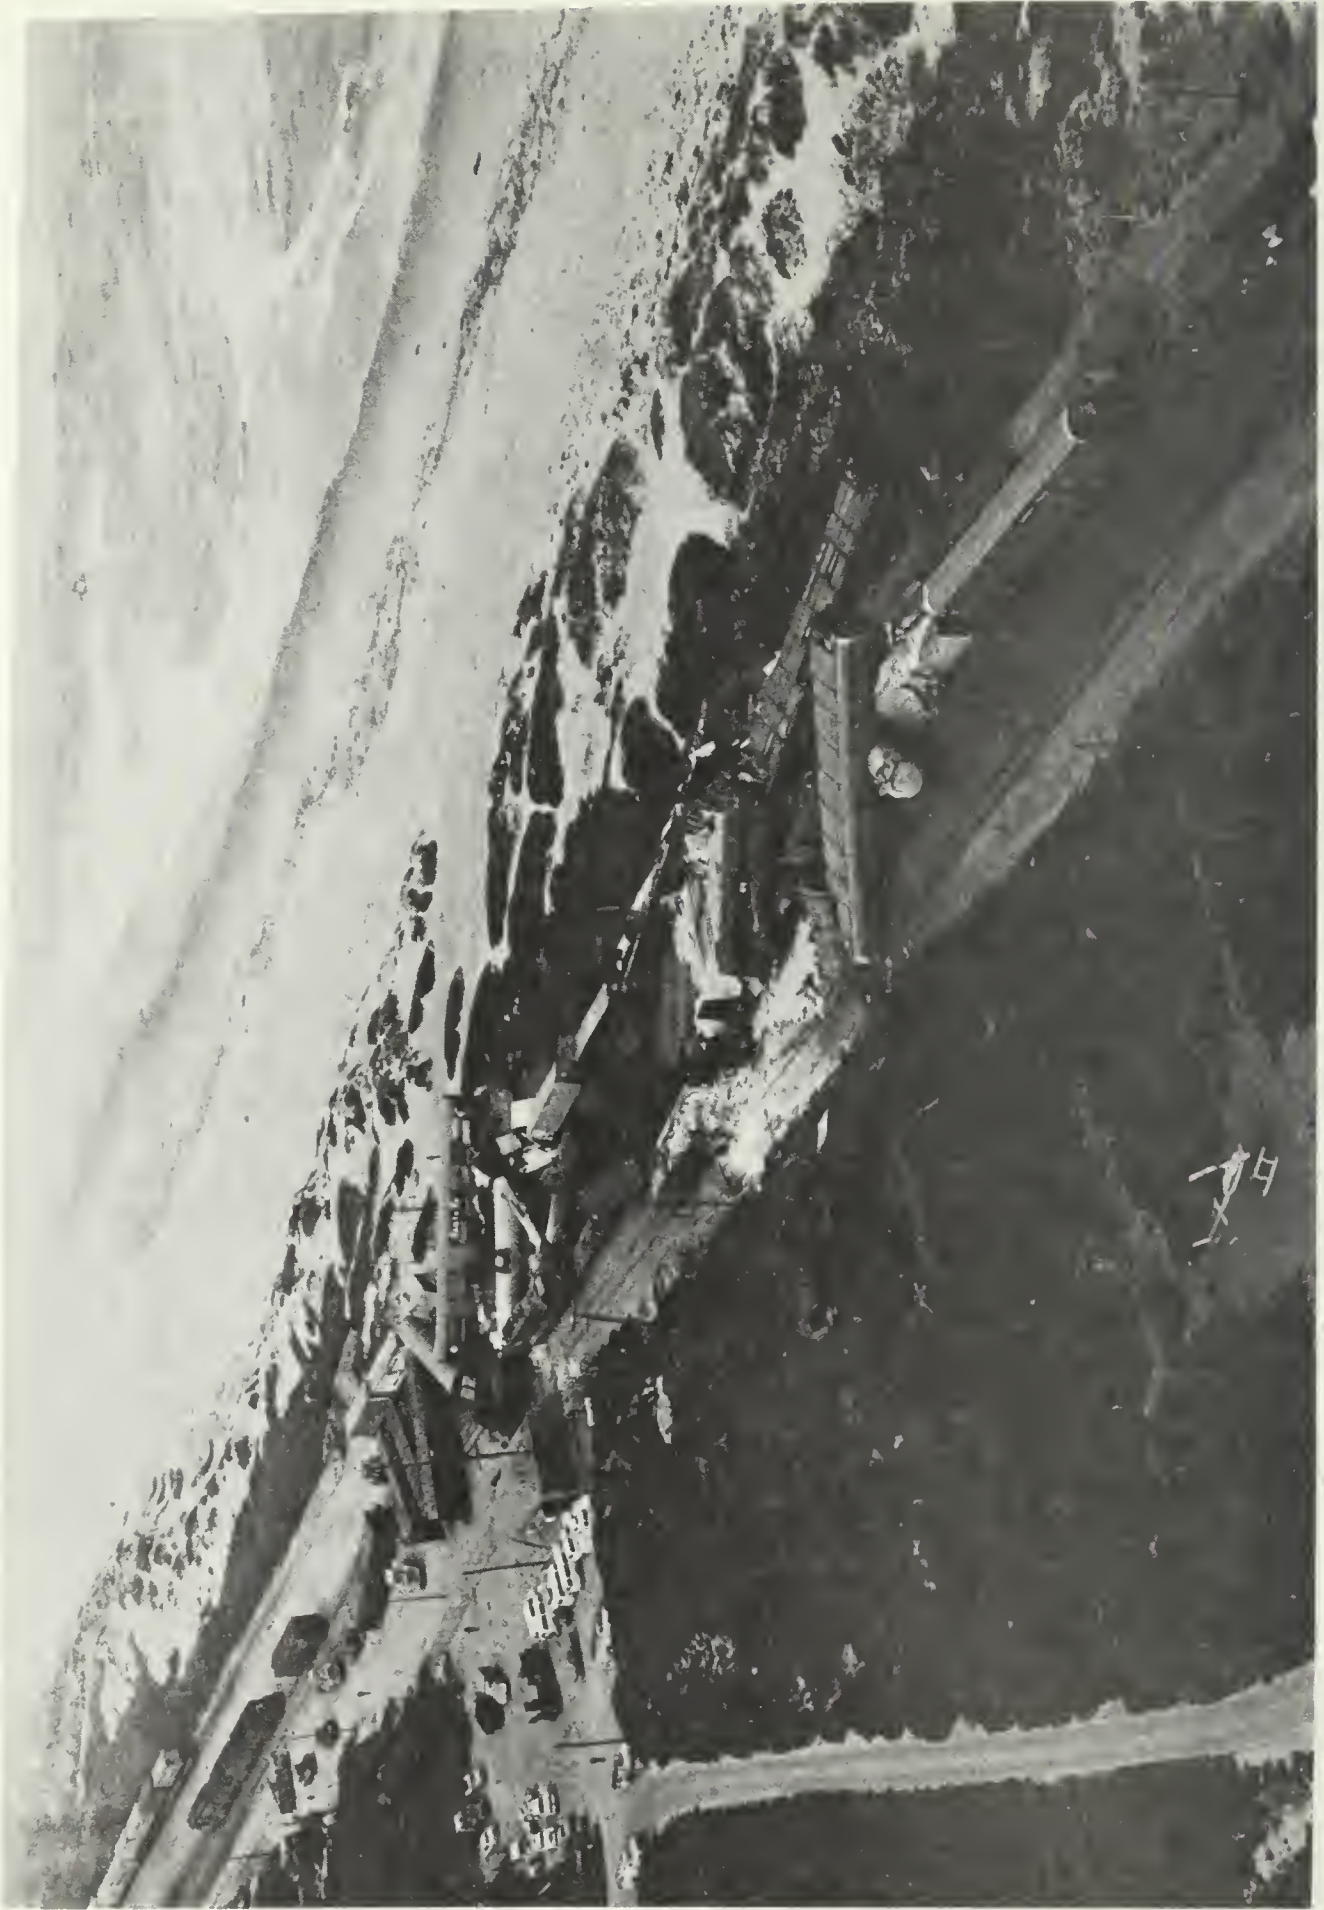
The R-3 wheel on the rear truck of the 53d car had a deep gash in the flange indicating that it had struck a sharp, rigid object. The front truck of the 54th car was derailed but the trailing truck of that car was not derailed. Wheel flange marks were found on the center sill of the 54th car, which may have derailed at the same time that the 53d car derailed. The remaining derailed cars were jackknifed or stacked between the house track and the siding south of the main track, east of the crossover.

Figure 2.—Accident site.

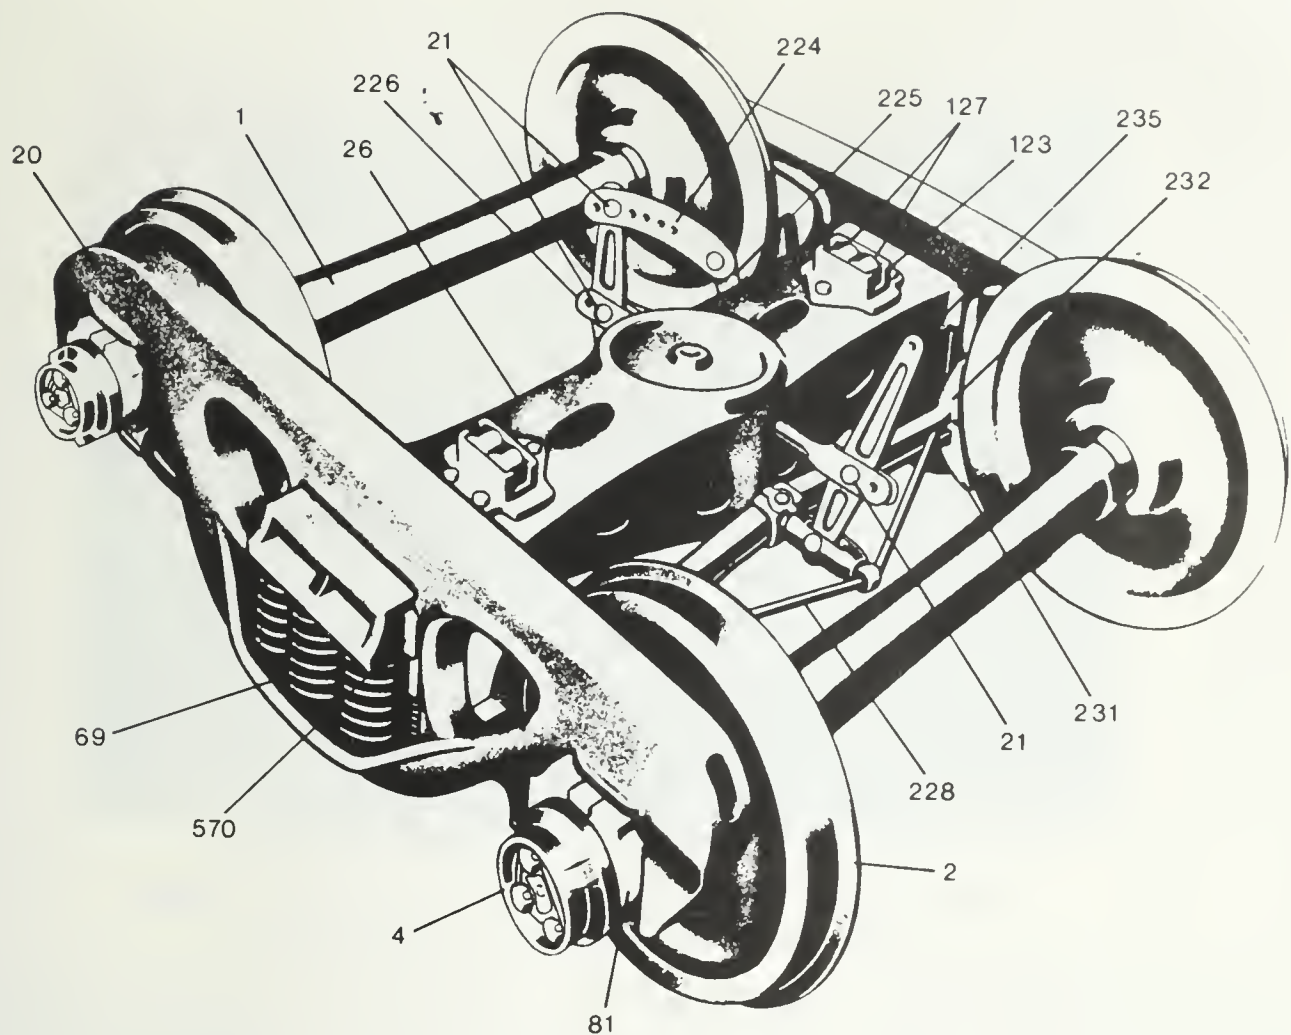
The "R" end of the brake beam that was believed to have come out of the "A" truck of the 53d car had been cut off with an oxygen-acetylene torch after the derailment. The

Figure 3.—Freight truck similar to the truck
from the "A" end of the 53d car.

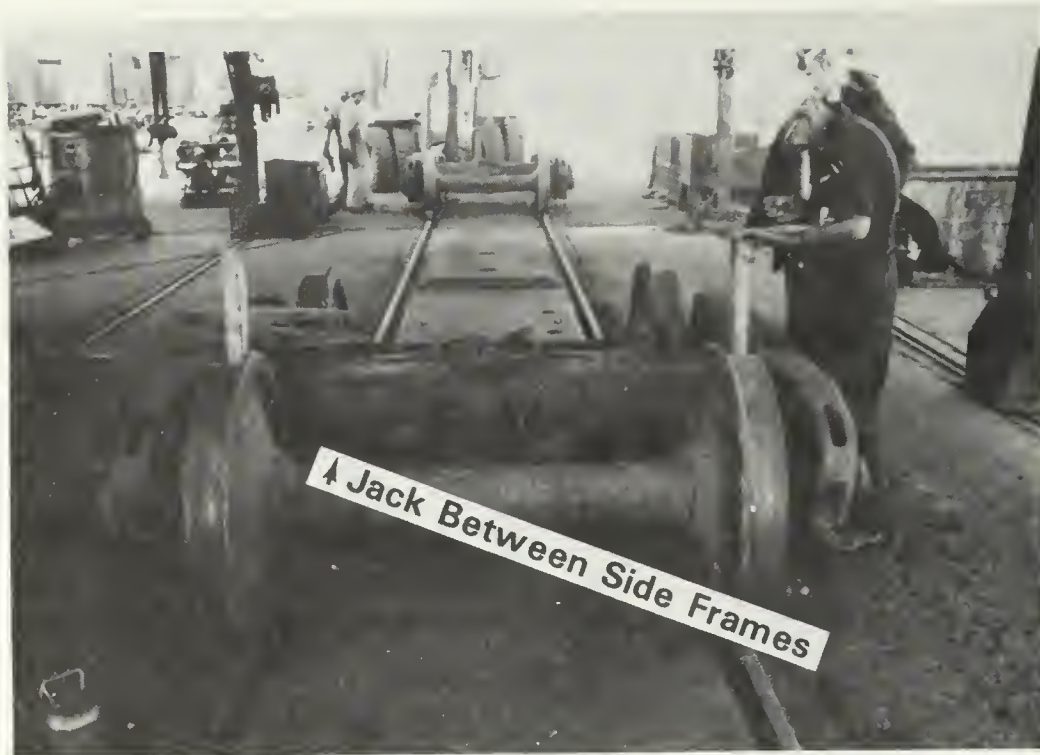
Figure 4.—Air jack in place shown forcing side frames apart on the "A" end truck of the 53d car.
